**TRANS ASIA**  
Industrial Laboratories

## FAILURE ANALYSIS

This Pre-Qualification Document (PQD) contains details about the Failure Analysis Services offered by Trans Asia. It outlines our capabilities, methodologies, and technical expertise in identifying the root causes of material, component, and system failures. The document demonstrates our systematic approach to investigating failures, implementing corrective actions, and preventing recurrence. It also highlights our commitment to quality, reliability, and continuous improvement in support of our clients' operational and safety objectives.

4 Sample Report 45

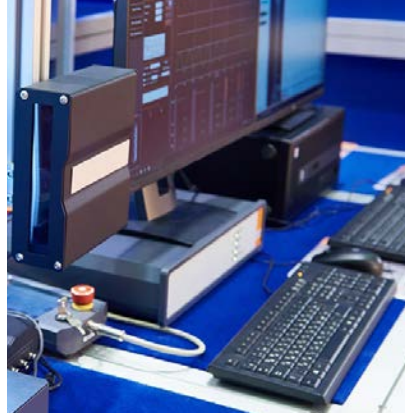
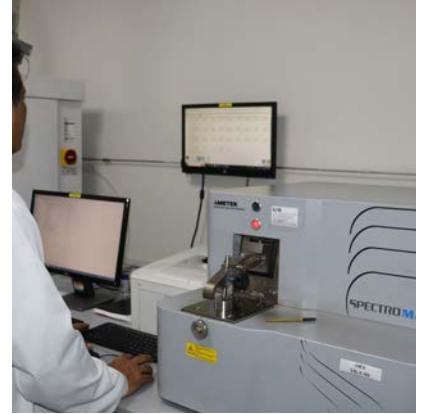
## Optical Microscope Metallographic Analysis

Metallography is frequently used to determine the material type, grade, or grain size, the inclusion content of a metal, test the corrosion resistance of a coating or material and provide certifications for new material or mixed batches, microstructure analysis, and failure analysis.

Stereo microscopy is used in conjunction with macro photography to closer document a fracture, weld, contamination or other feature of interest. The stereo microscope is an optical microscope designed for low magnification (up to 80X) observation of a sample.

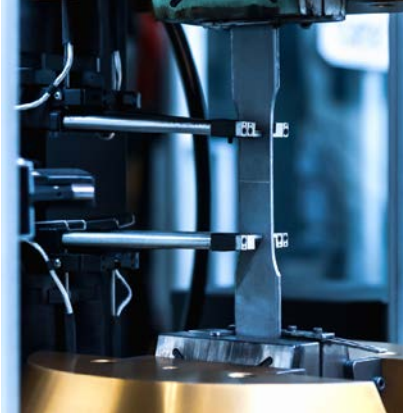
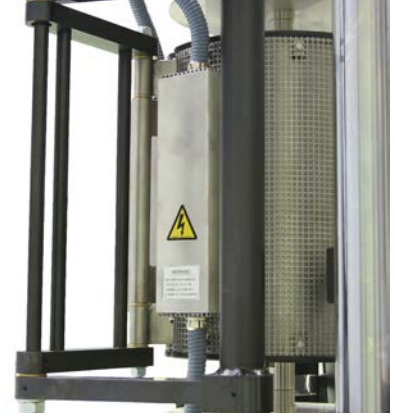
## UTM Tensile Test

TIL's tensile testing labs provide conditions for exposing materials to a static or slowly applied force, determining their ultimate tensile strength. We perform industry-leading tensile tests for many metallic or non-metallic materials, at applicable room temperature or elevated temperature.

Fatigue testing characterizes material or component behavior during cyclic loading. Our test machines can help test cyclic loads for vital properties, such as fatigue failure, fatigue limit, and fatigue life. Our analytical testing services utilize cyclic loads in test machines to understand fatigue failure.

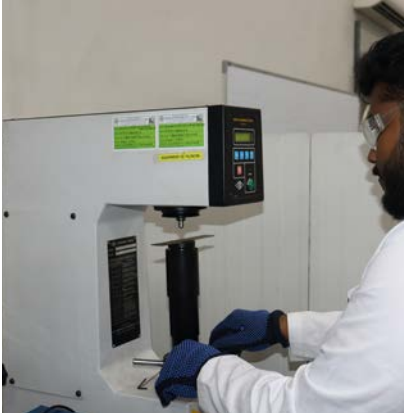
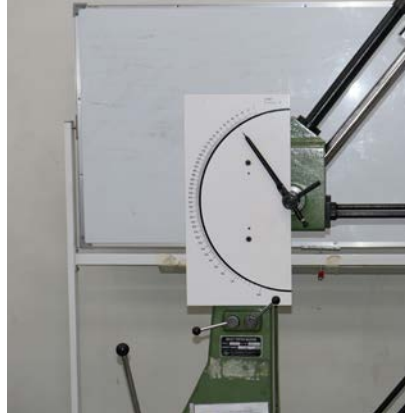
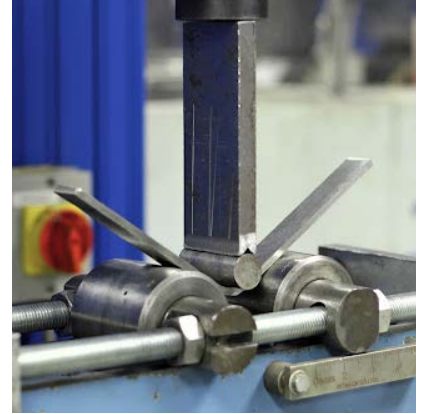
## HV, HRC, BHN Hardness Test

Hardness testing applies to a range of materials, both metals, and nonmetals alike, and determines how resistant a material is against deformation, penetration, scratching, or other physical force. Our experts perform hardness testing according to the requirements of the material and its applications.

Impact strength tests are designed to determine the notch toughness of a material by measuring the amount of energy absorbed as it fractures. The Charpy impact test is one of the most popular techniques for determining material notch toughness and helps ensure the safety and integrity of structure.

These test methods cover bend testing for ductility of materials. Bend tests for ductility provide a simple way to evaluate the quality of materials by their ability to resist cracking or other surface irregularities during one continuous bend. No reversal of the bend force shall be employed during these tests.

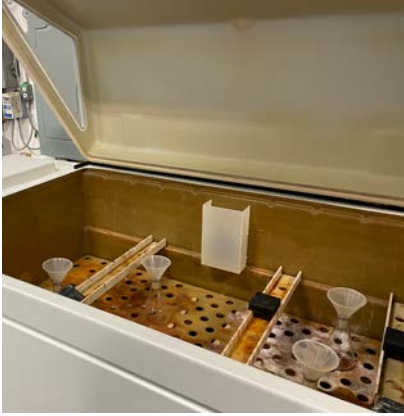
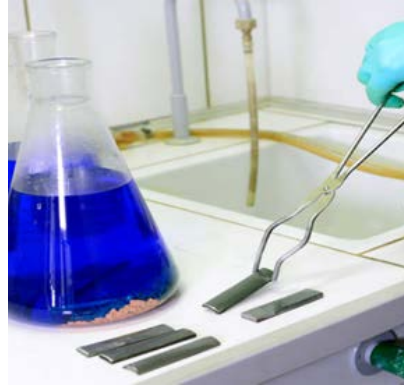
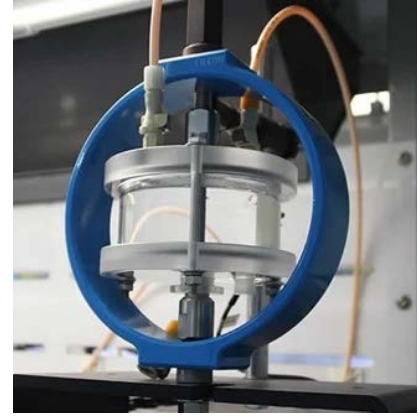
## SST Salt Spray Test

At TIL, our high-capacity salt spray testing labs can test a number of test specimens of many sizes, shapes and dimensions for the Salt Spray Test. We can also accommodate the duration of the exposure for the test according to specific to customers' requirements.

Our corrosion experts follow international testing standards and protocols such as ASTM, NACE, and API. We can assist you with a wide range of corrosion testing services and evaluations, material selection, corrosion assessments, recommending efficiencies, and preventative mitigation measures.

Our sour service labs use hydrogen sulfide and other sour gases to replicate the highly aggressive conditions found in the Oil & Gas industry. TIL's specialized corrosion laboratories meet stringent international standards with a variety of traditional and advanced sour service corrosion testing.

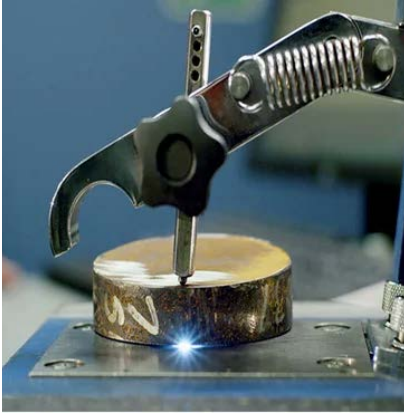
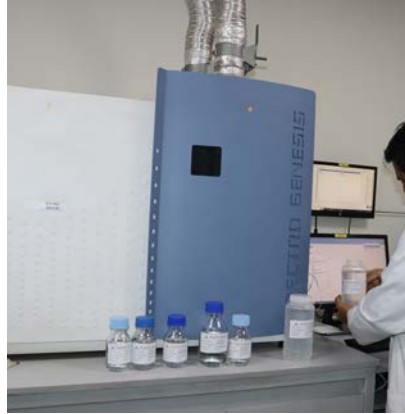
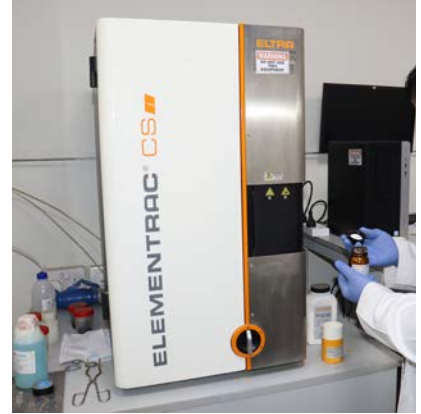
## OES Chemical Test

TIL has chemical analysis laboratories across the US, Europe, and Asia, allowing you worldwide access to our trusted expertise and unique range of services. From trace metals identification to comprehensive failure analysis programs, our experts provide the certainty your project requires.

Elemental analysis using LECO and ELTRA are reliable methods for determining the concentration of elements within a metallic sample, including Carbon, Hydrogen, Nitrogen, Oxygen and Sulfur. Our experts help industries to quantify these elements in their material.

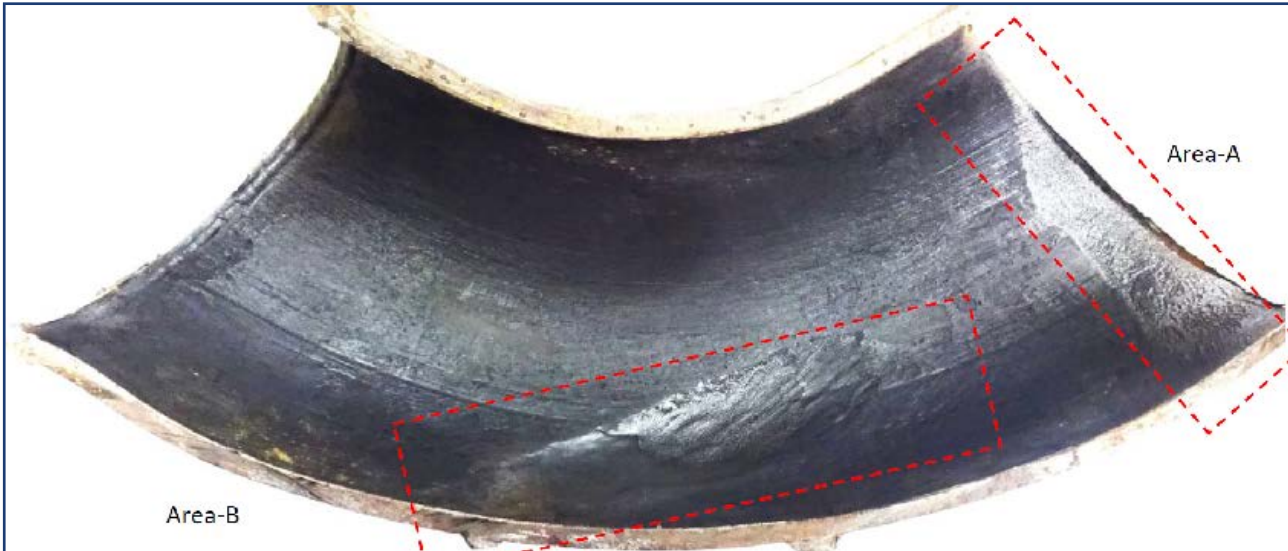
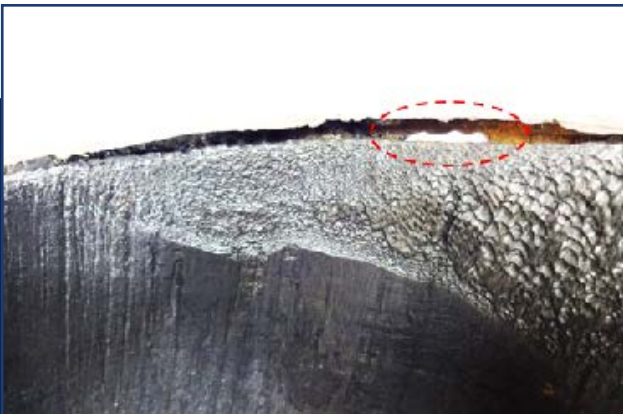
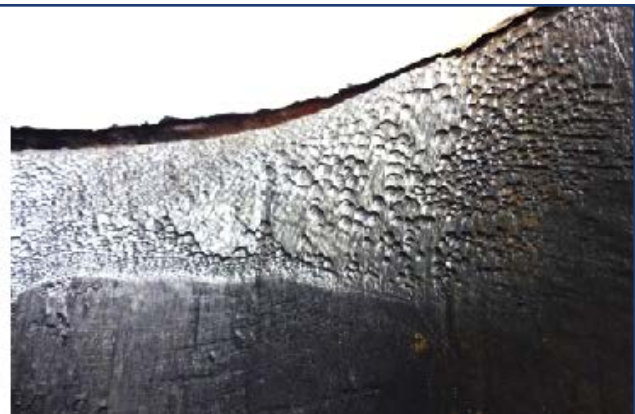
## CASE 1: FAILURE ANALYSIS ON LEAKED ELBOW FROM CONDENSATE PIPING NETWORK

In a condensate piping network, 2 elbow and 1 equal-tee were found leaking. An Elbow – 6" Sch. Std. from the condensate piping network was sent to us for Failure Analysis, where the component had a through thickness hole at weld.

Although, the chemical composition, mechanical properties and microstructures of the elbow were typical of the grade requirement of ASTM A234 Grade WPB. However, the weld chemical composition was not found matching to the grade requirement. The visual examination and stereo-examination evidenced honeycomb-shaped

cavities near the leak at damage, and general erosion-corrosion thinning at damage away from leak. The wall thickness loss of approx. 3mm was observed on the damaged area. Based on detailed failure investigation carried out in the laboratory on the failed portion of the elbow, leakage and thinning happened due to combination of erosion-corrosion and cavitation-erosion. And the contributing factor for erosion-corrosion that led to leakage and thinning were abrasive compounds, inhomogeneity in microstructure near welding, bubble impingement at the transition near weld.

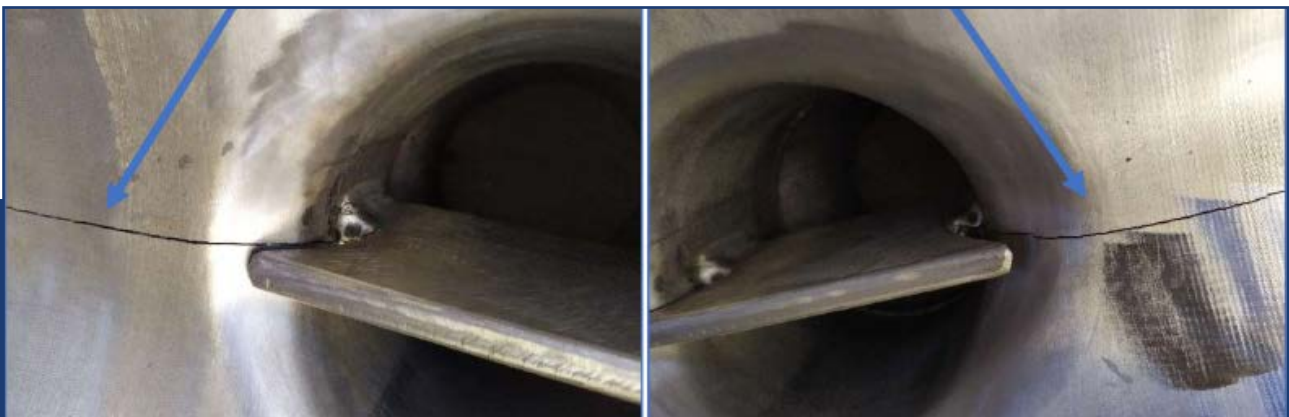
## CASE 2: LEAKAGE AND CRACKS ON SEAMLESS PIGGABLE BARRED TEE

The leakage along the crotch area of the one of the 10" x 6" barred tees on both sides of the branch during initial pressurization for hydrotest of the manifold was observed. Linear cracks on the shoulder/crotch of the barred tee were discovered on either side.

Two prominent cracks were observed in the shoulder of the barred Tee in longitudinal direction during hydro-test as a part of FAT activities. No other anomalies were observed in pipe to Tee weld joints. These two cracks were observed to be propagating near welded bar section from the inner surface of the tee and traversing

Although the chemical composition of the material found meeting the grade requirement of 25% Super Duplex Stainless Steel (UNS S32760), non-conformity in mechanical properties like tensile, hardness, impact, inhomogeneity in microstructures and deviation ferrite content were reported after tests.

Based on the detailed investigations & laboratory test results, the cracks in the tee body developed because of inhomogeneity and significant presence of deleterious phases resulting in embrittlement due to improper thermal cycle exposure.

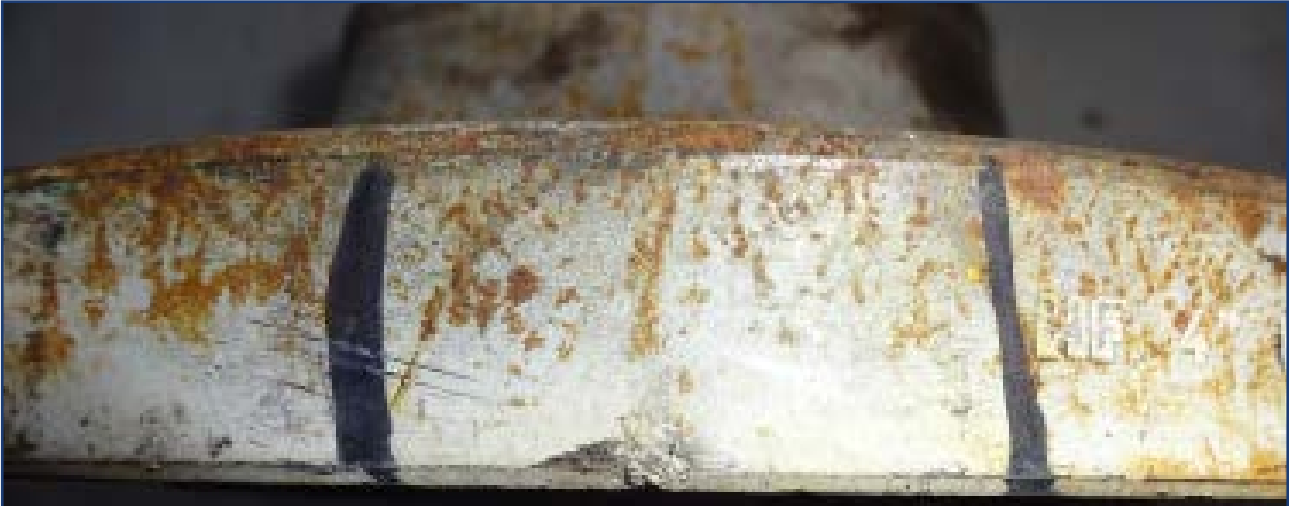
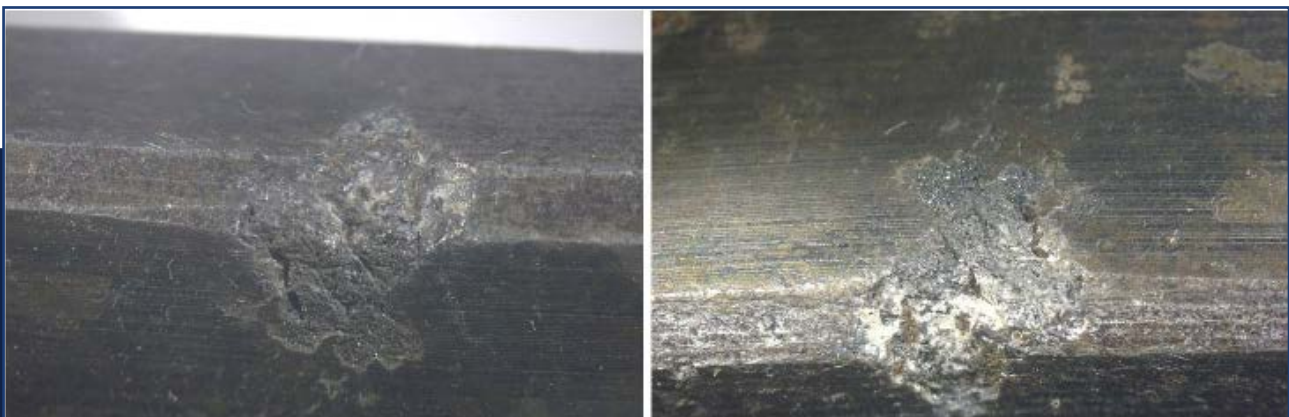
## CASE 3: FAILURE ANALYSIS ON CRACKED CS FLANGE

After welding of pipe to the flange, a crack was observed while performing inspection on the joint. Two such flanges were under failure investigation.

Although the tensile properties of one flange were found to be complying, the test result for other flange did not meet the requirement of specified grade ASTM A105. While the general core microstructure was found typical of the grade, however long interlinked embedded foreign material was observed in the microstructure at location near the crack.

The defect area was observed and characterised using SEM. And the SEM

micrographs showed the disbonding of the metal matrix in the cracked region, which subsequently formed deep recess which were observed in each SEM images.

So the defect was primarily foreign material, deemed to be slag, the brittle nature of foreign material, made the flange susceptible to cracking under stress condition.

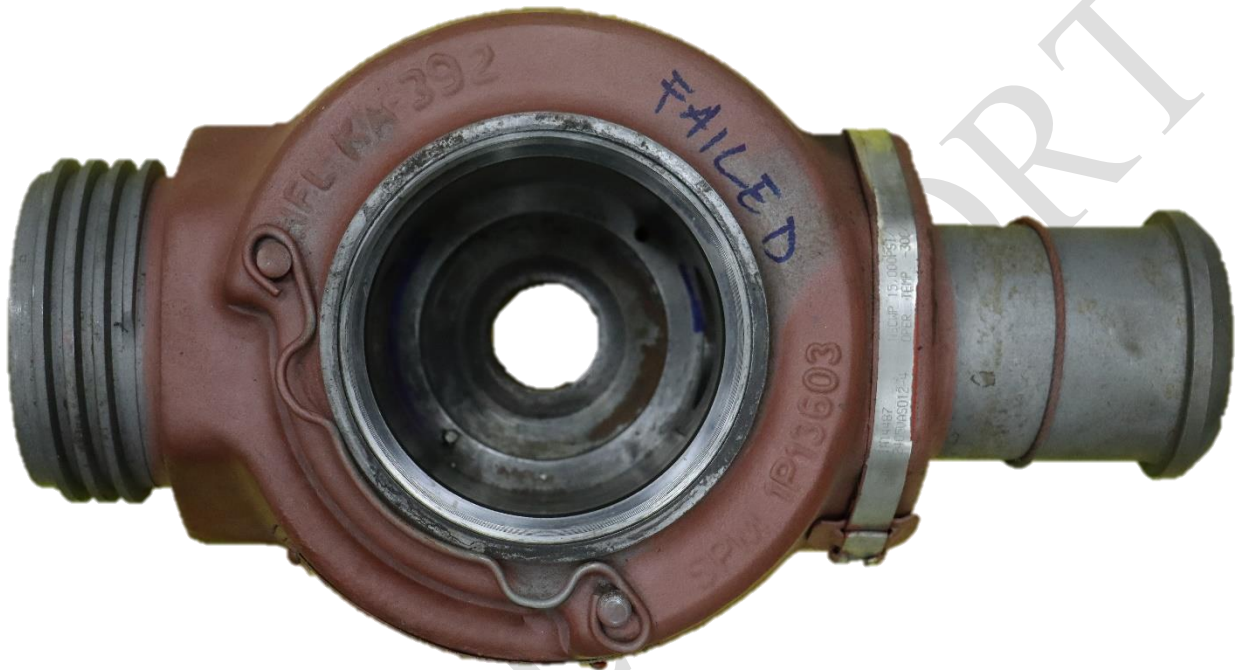
**Photograph # 2:** As-received condition of the plug valve showing intact external body with red-oxide coating and manufacturer identification markings. No mechanical damage, deformation, or cracks were visible on the outer surface.

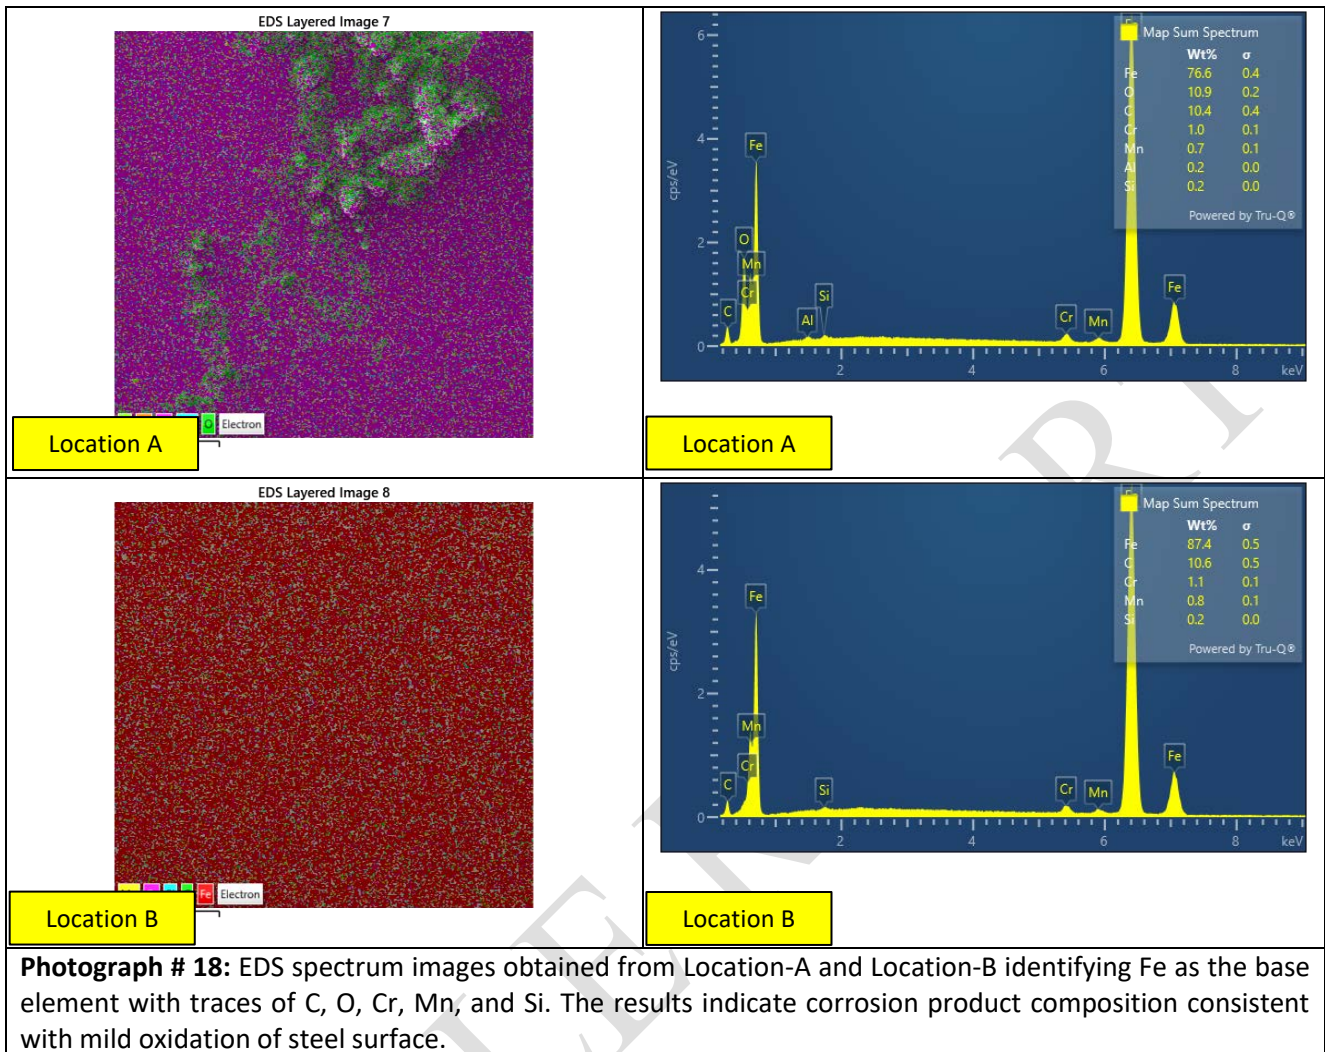
Scanning Electron Microscopy (SEM) combined with Energy Dispersive Spectroscopy (EDS) was performed on specimens extracted from the plug-valve body (Case 1) to characterize pit morphology, surface deposit composition. The examination was conducted in accordance with ASTM E1508. Three analysis sites were selected: Location A on the affected corroded zone, and Locations B and C on the unaffected core regions.
